## APPENDIX G – Examples of Greenline Locations

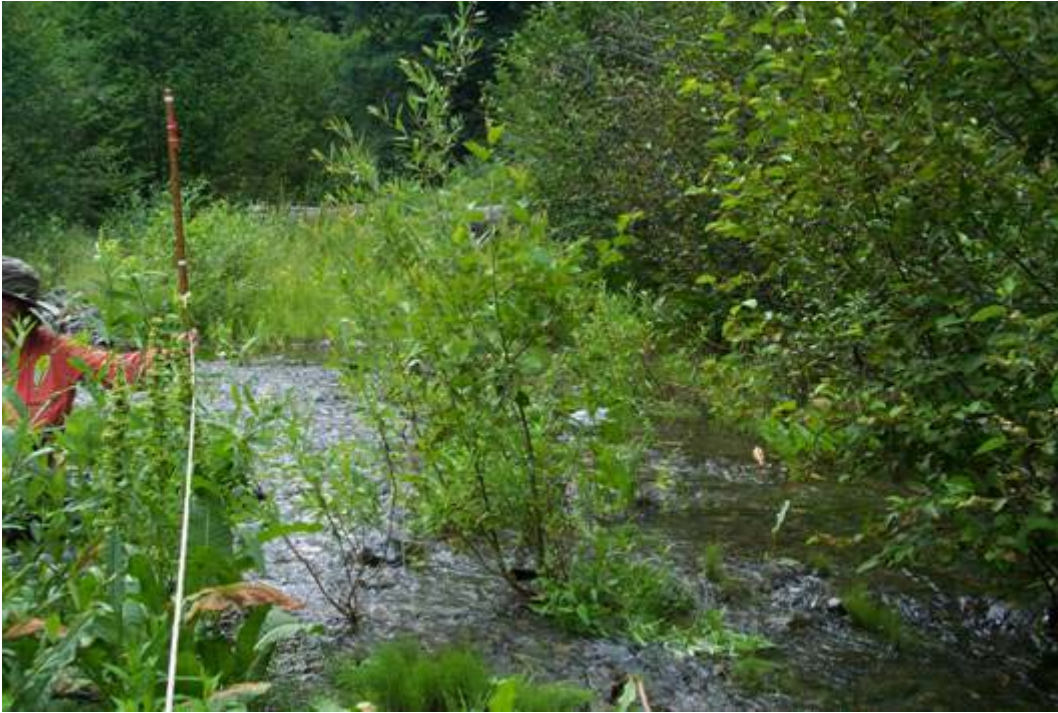
**Figure 1**—vegetation growing within the stream channel is not part of the greenline.  
Photo - PIBO, U.S. Forest Service

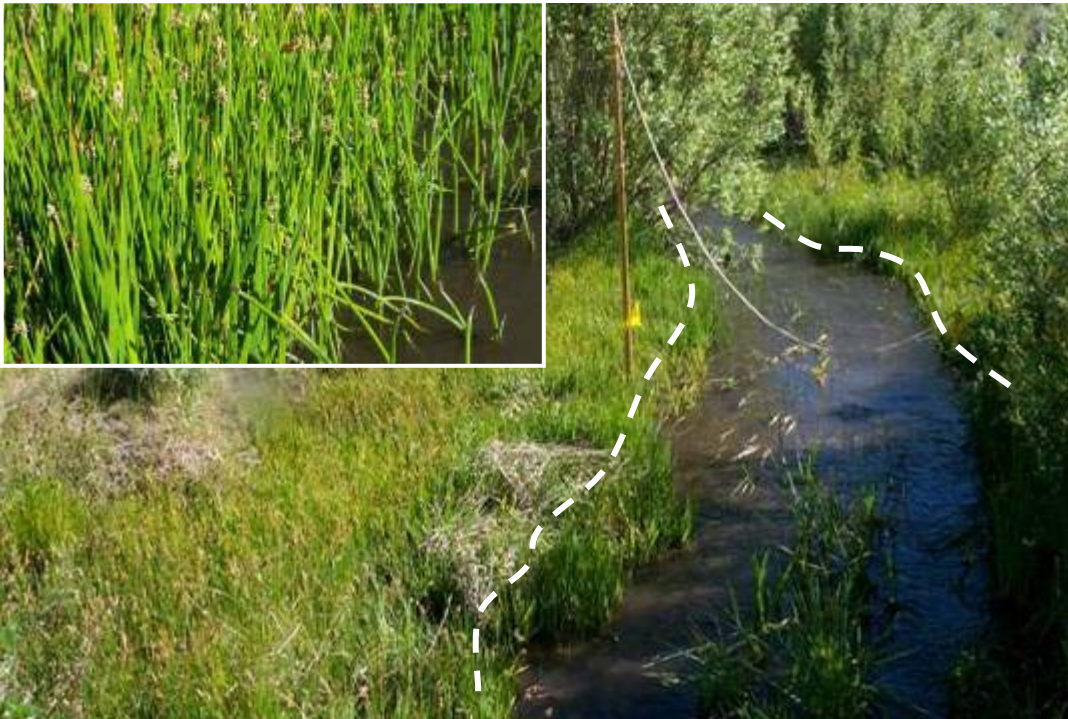
**Figure 2**—the greenline follows the vegetation line even when the vegetation is in shallow water. The inset picture shows spike rush (*Eleocharis* sp.) growing in shallow water along the margin of the stream. Photo - PIBO, U.S. Forest Service

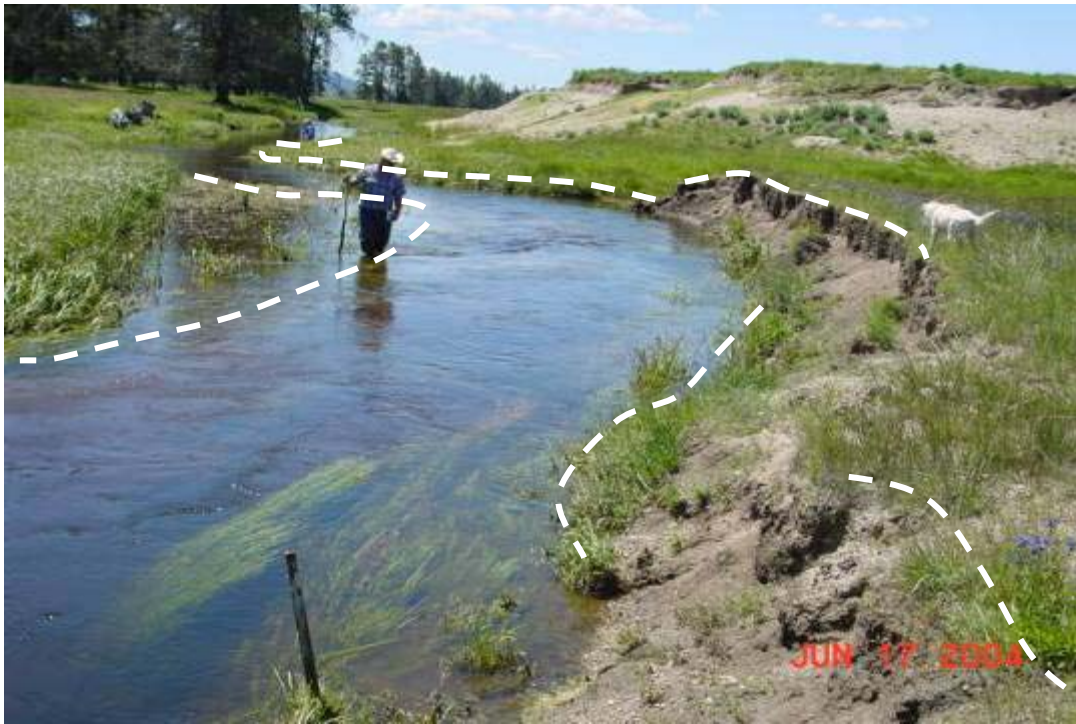
**Figure 3**—the greenline is below the water surface as the stream is well above the bankfull flow level. It is much easier to discern the greenline when streams are at summer low flows or below bankfull.

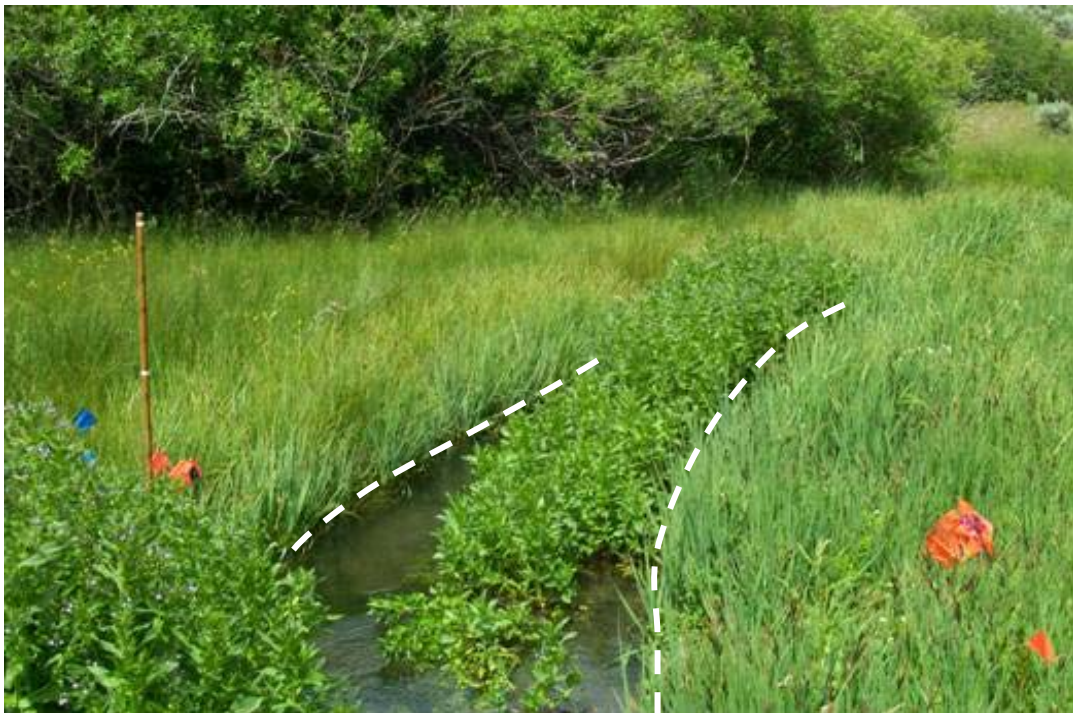
**Figure 4**—the greenline follows the (*Carex* sp.) on each side of the stream. Water speedwell (*Veronica anagallis-aquatica*) growing in the stream is not part of the greenline. Photo - PIBO, U.S. Forest Service

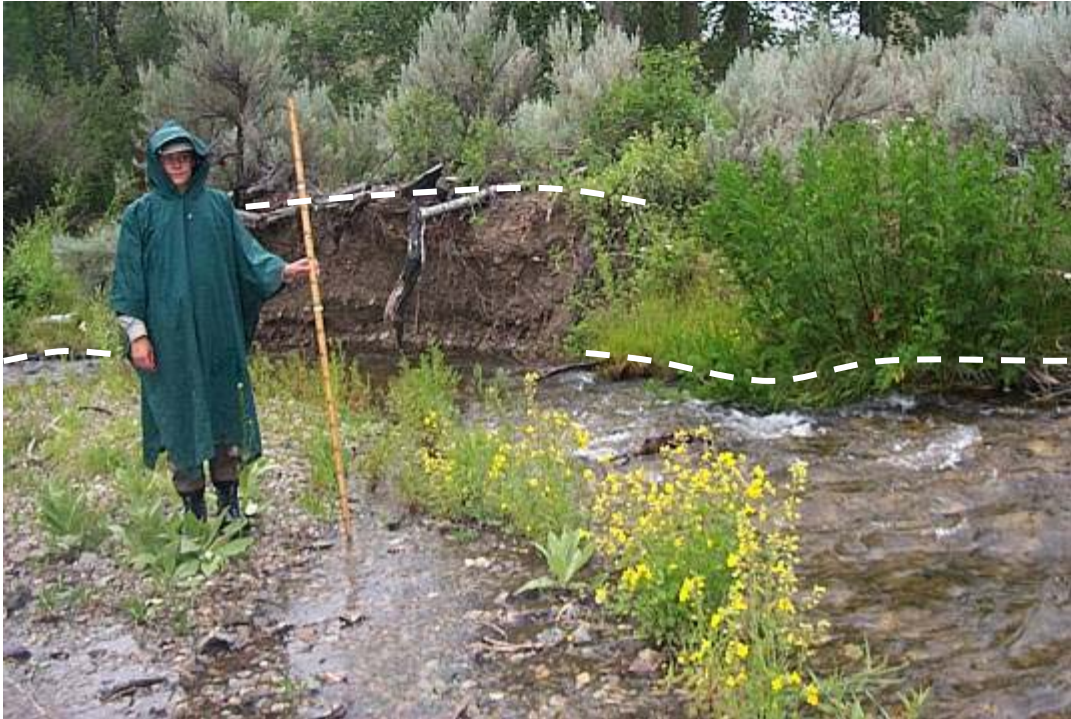
**Figure 5**—monkey flower (*Mimulus guttatus*) is an annual or short-lived rhizomatous perennial colonizing species. It is not included as a greenline species. Photo - PIBO, U.S. Forest Service

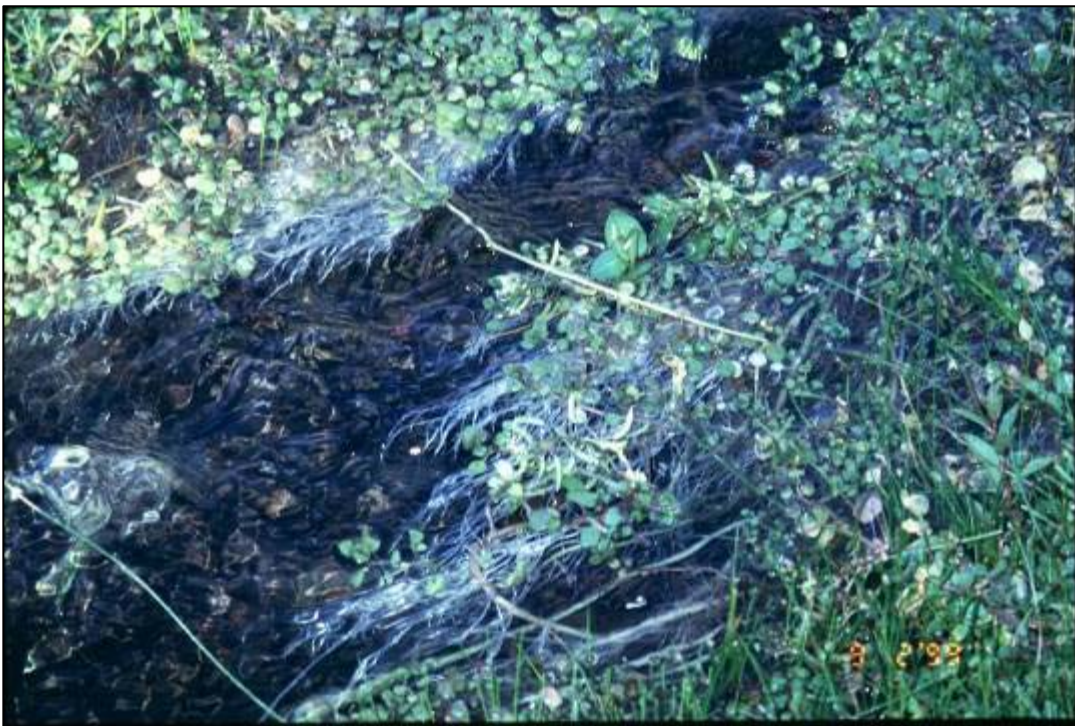
**Figure 6**—watercress (*Rorippa nasturtium-aquaticum*) is not considered part of the greenline. It should be noted in the remarks section.

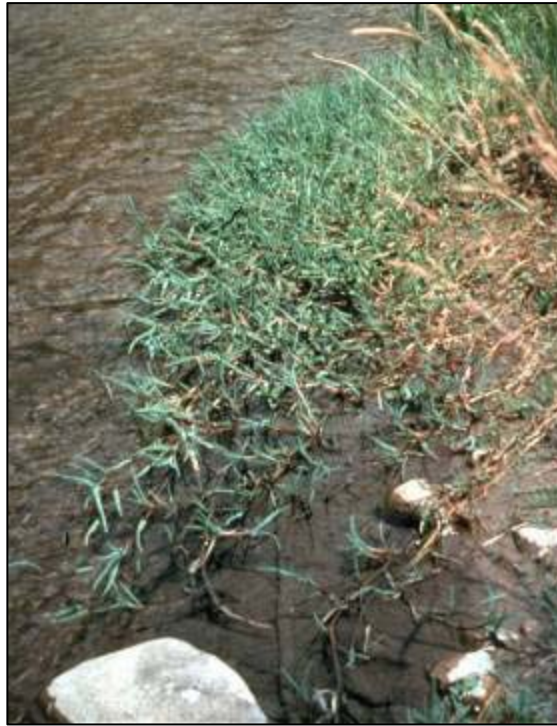
**Figure 7**— brookgrass (*Catabrosia aquatica*) is a short-lived perennial grass that occasionally grows on the streambank. It grows mostly in the margin of a stream. It is not considered part of the greenline.

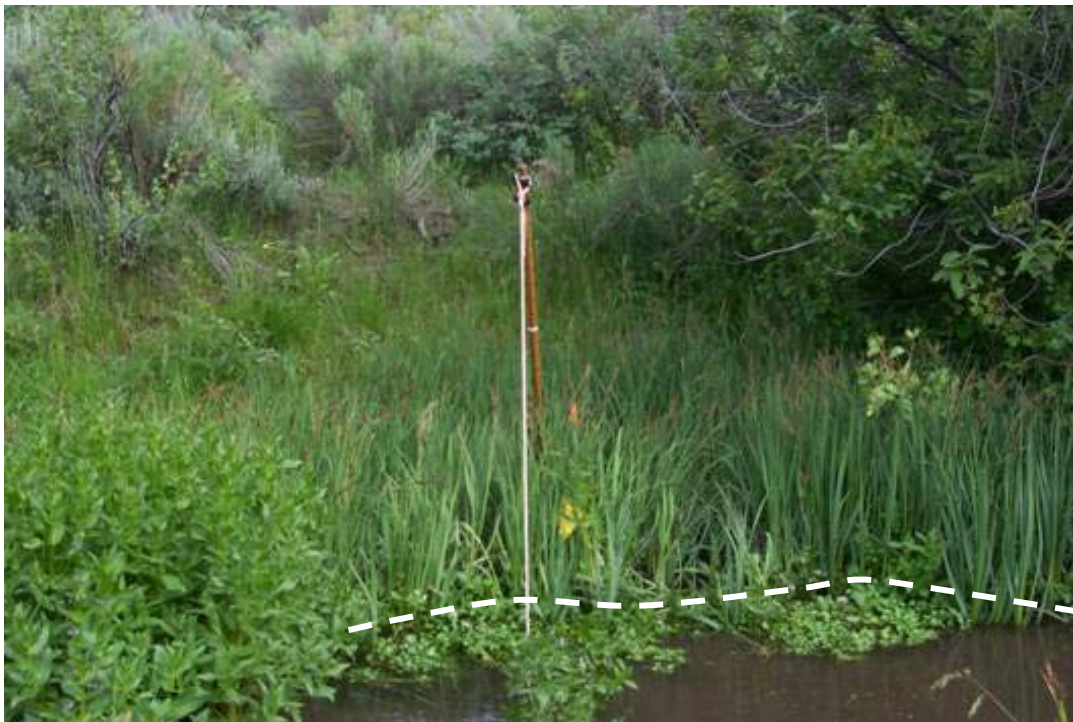
**Figure 8**—greenline follows the sedge (*Carex* sp.) or the edge of the water if the *Carex* sp. is in the water and not floating such as speedwell (*Veronica* sp.) and watercress (*Rorippa nasturtium-aquaticum*). Photo - PIBO, U.S. Forest Service
